**Flood Control Project Maintenance
Levee Inspections****LMA District Cover Sheet****Spring 2011 Levee Inspection Results****San Joaquin County Flood Control and Water Conservation District**

Spring 2011 Levee Inspection Results

San Joaquin County Flood Control and Water Conservation District

Waterway			Bank	Unit Miles
Unit No. 01 Littlejohn Creek			Left	2.87

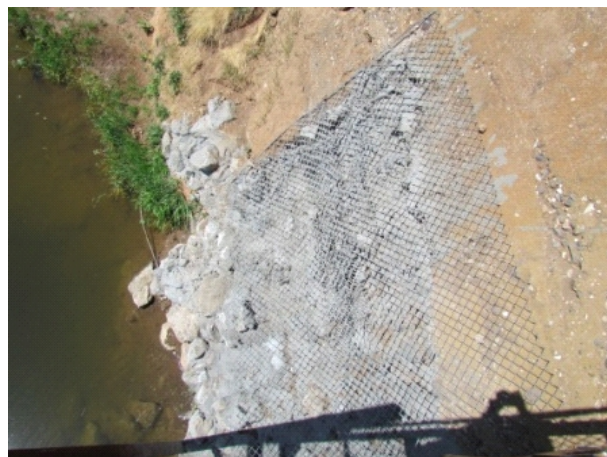
Levee Mile Report Line	31
Start Levee Mile	3.14
End Levee Mile	3.14
Location	Water Side
Category	Earthen Levee
Item	Erosion / Bank Caving

Rocks have been placed to control the erosion on the waterside slope of the levee. The picture was taken at the location of the pipe looking waterside of the levee.

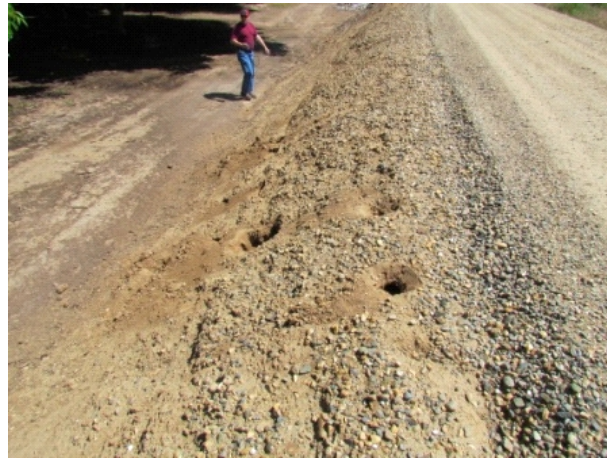
Rodent holes was found on the landside of the levee. The picture was taken from the crown looking upstream.

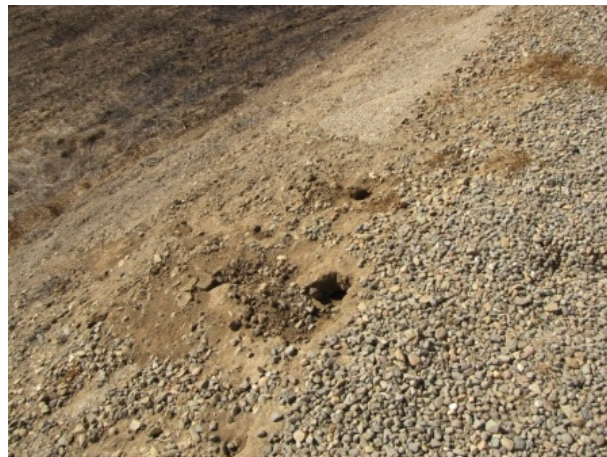
Levee Mile Report Line	39
Start Levee Mile	3.37
End Levee Mile	3.37
Location	Water Side
Category	Earthen Levee
Item	Animal Control

View of rodent holes in the waterward slope looking downstream.

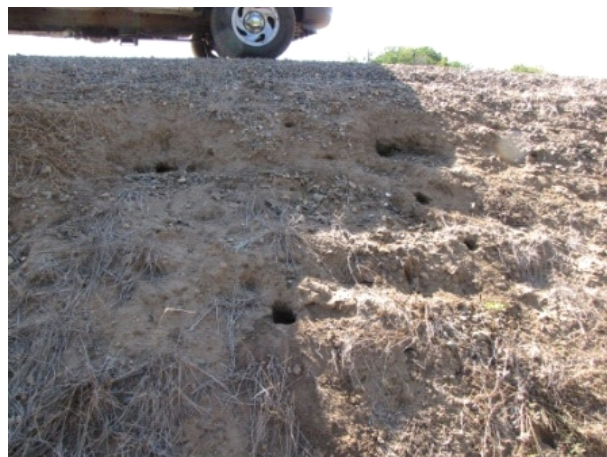
Levee Mile Report Line	41
Start Levee Mile	3.40
End Levee Mile	3.40
Location	Land Side
Category	Earthen Levee
Item	Animal Control

View of rodent holes on landward slope of levee.

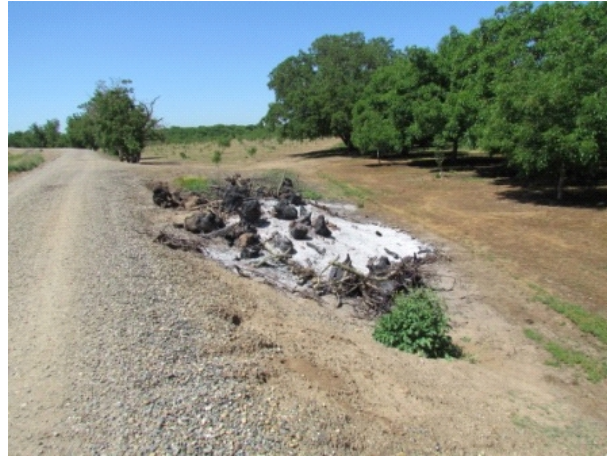
Burn pile and new material was placed at the toe of the landside of the levee. The picture was taken from the crown looking downstream.

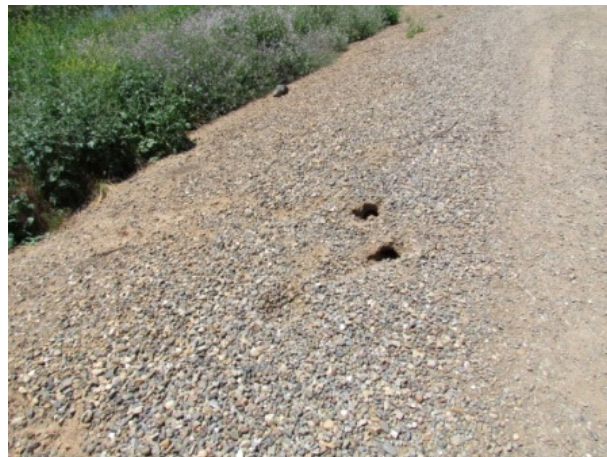
Levee Mile Report Line	43
Start Levee Mile	3.41
End Levee Mile	3.41
Location	Water Side
Category	Earthen Levee
Item	Animal Control

Rodent holes was found on the waterside of the levee. The picture was taken from the crown looking downstream.

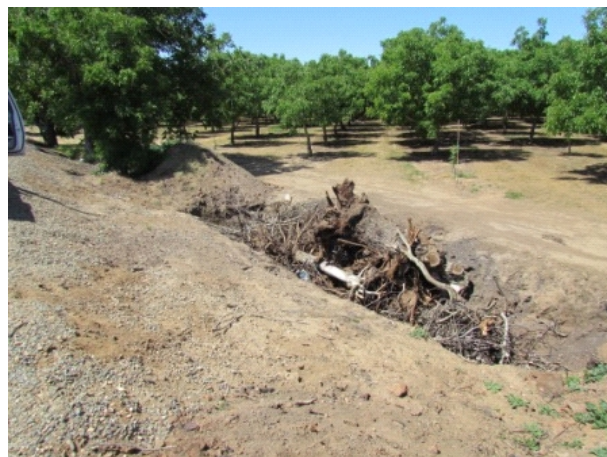
Levee Mile Report Line	46
Start Levee Mile	3.61
End Levee Mile	3.61
Location	Land Side
Category	Earthen Levee
Item	Slope Stability

A pit was dug out by the farmers at the toe of landside of the levee. The picture was taken from the crown looking downstream.

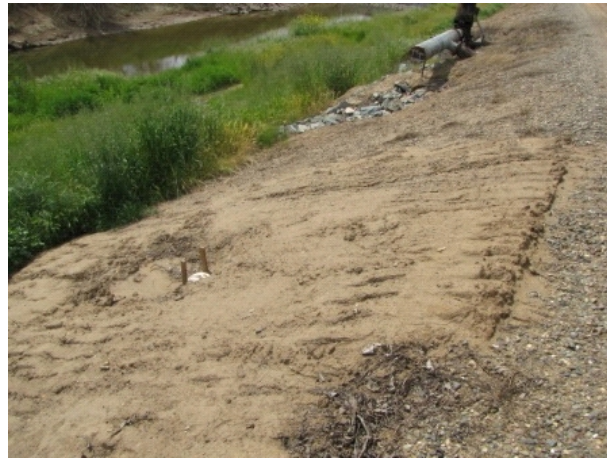
View of a recently place pipe in the waterward slope looking downstream.

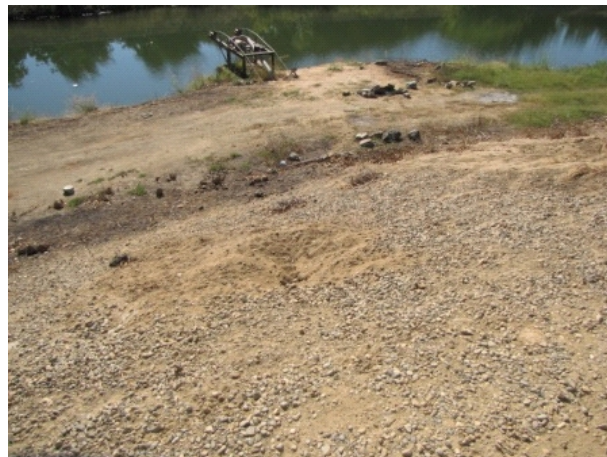
Levee Mile Report Line	48
Start Levee Mile	3.63
End Levee Mile	3.63
Location	Water Side
Category	Earthen Levee
Item	Animal Control

View of a rodent hole and tailings on the waterward slope looking waterward.

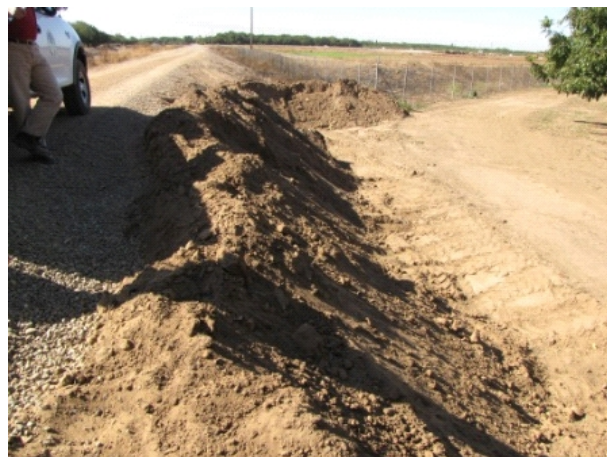
Levee Mile Report Line	49
Start Levee Mile	3.64
End Levee Mile	3.66
Location	Land Side
Category	Earthen Levee
Item	Slope Stability

View of excavations and embankments created by landowner along the landward slope looking downstream.

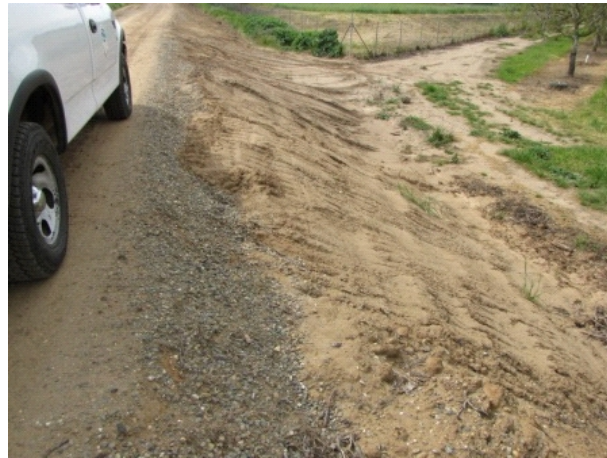
Updated view of the location with a partially completed repair looking downstream.

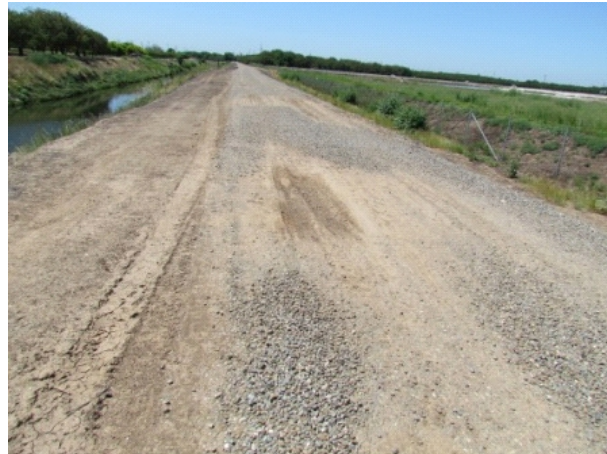
Levee Mile Report Line	51
Start Levee Mile	3.72
End Levee Mile	3.72
Location	Crown
Category	Earthen Levee
Item	Crown Surface / Depressions / Rutting

Depression on the crown was found due to vehicular traffic. The picture was taken from the crown looking downstream.

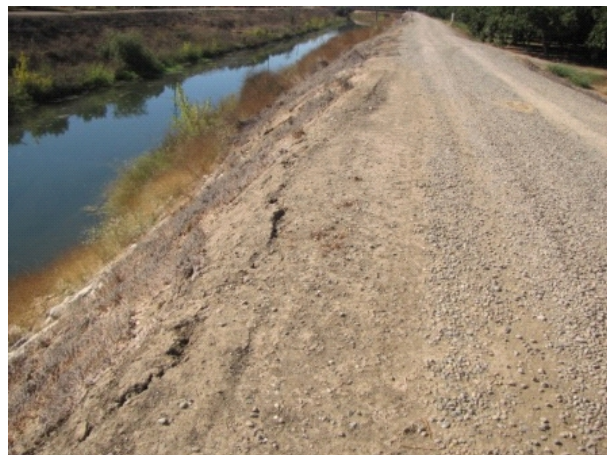
Levee Mile Report Line	53
Start Levee Mile	3.92
End Levee Mile	3.92
Location	Land Side
Category	Earthen Levee
Item	Cracking

View of cracking on the waterward shoulder occurring at an erosion repair looking downstream.

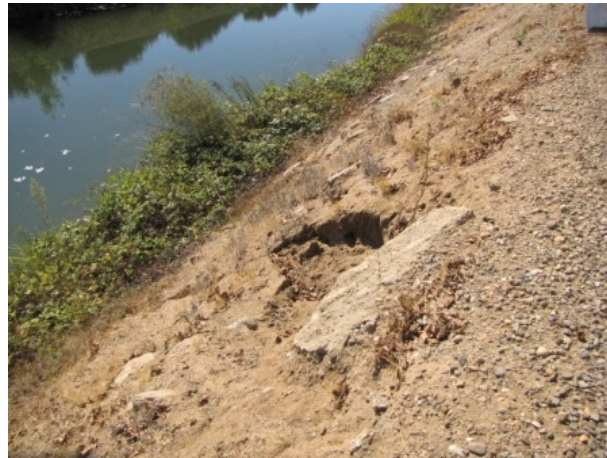
View of the rodent activity and resulting damage to the levee in the waterward slope looking downstream as of fall 2010.

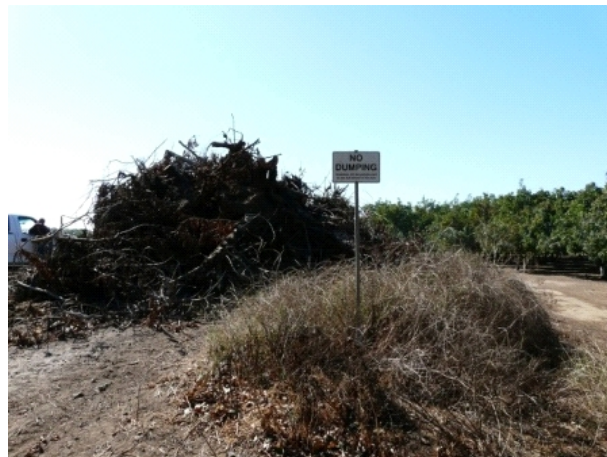
Levee Mile Report Line	58
Start Levee Mile	4.29
End Levee Mile	4.29
Location	Land Side
Category	Earthen Levee
Item	Encroachments

Example of a prunings pile immediately adjacent to access road at LM 4.29. Evidence of habitual burnings at this site.

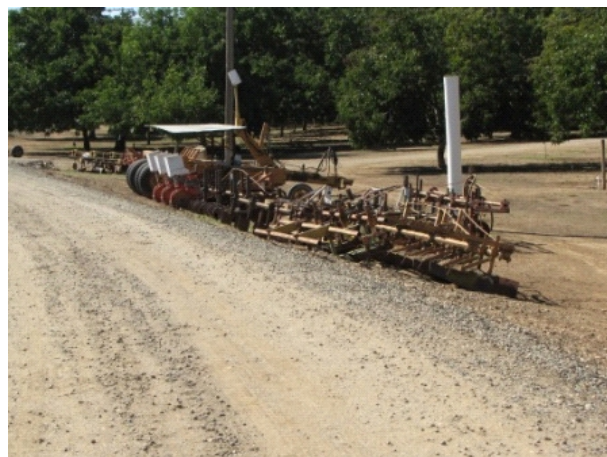
Levee Mile Report Line	63
Start Levee Mile	4.96
End Levee Mile	4.96
Location	Land Side
Category	Earthen Levee
Item	Encroachments

View of equipment along the landward slope looking downstream.

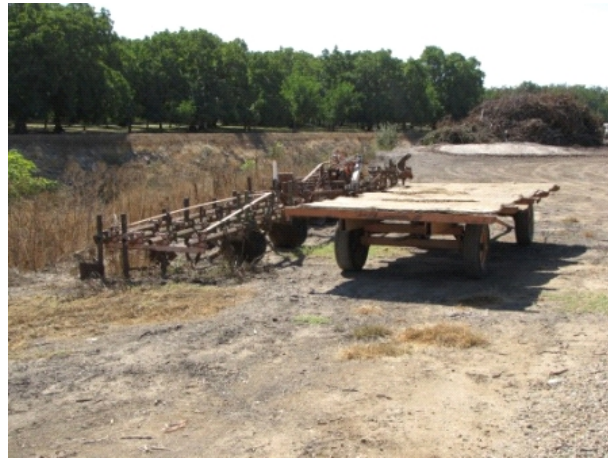
View of equipment along the waterward side of the levee crown looking downstream.

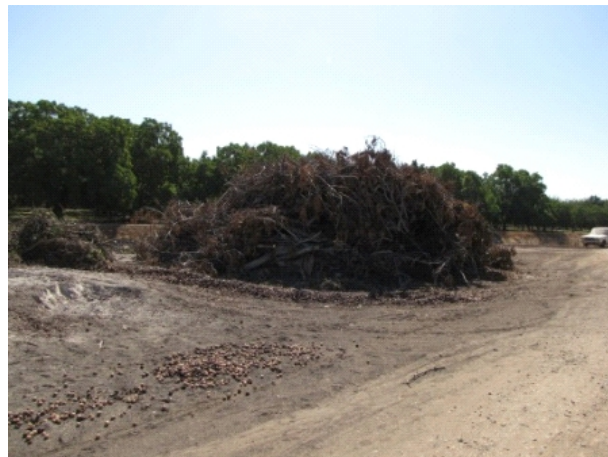
Levee Mile Report Line	65
Start Levee Mile	4.97
End Levee Mile	4.97
Location	Water Side
Category	Earthen Levee
Item	Encroachments

View of prunings pile along the waterward side of the crown looking downstream.

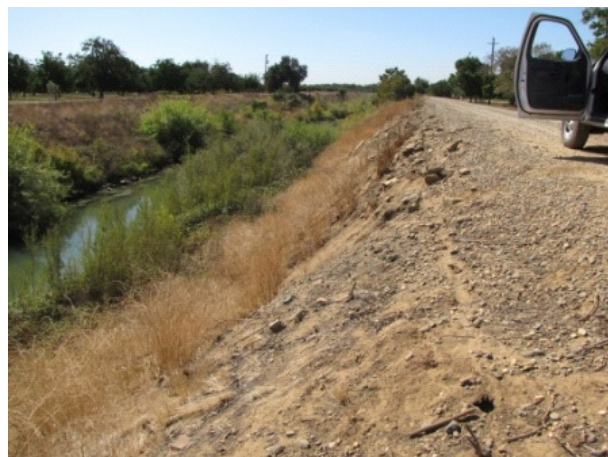
Levee Mile Report Line	67
Start Levee Mile	5.14
End Levee Mile	5.14
Location	Water Side
Category	Earthen Levee
Item	Slope Stability

View of a slip in the waterward levee slope looking downstream.

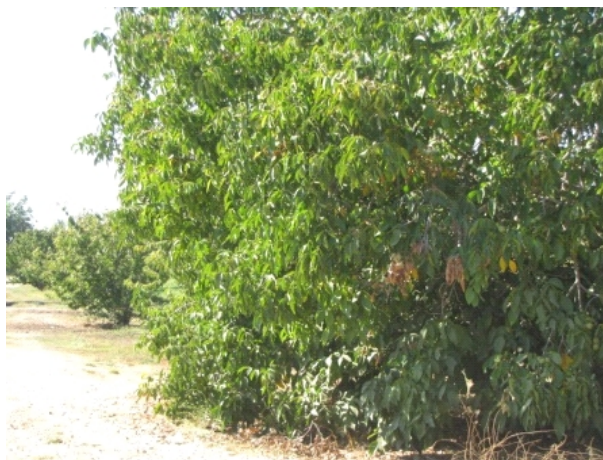
View of trees on the landward slope blocking visibility and access looking downstream.

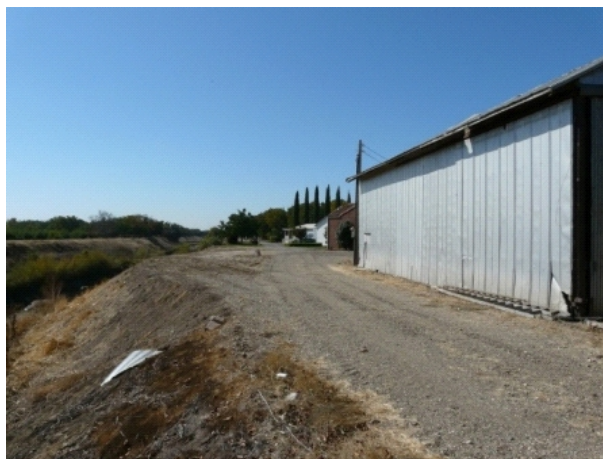
Levee Mile Report Line	72
Start Levee Mile	5.38
End Levee Mile	5.45
Location	Land Side
Category	Earthen Levee
Item	Encroachments

Building located immediately adjacent to access road approximately from LM 5.38 to 5.45

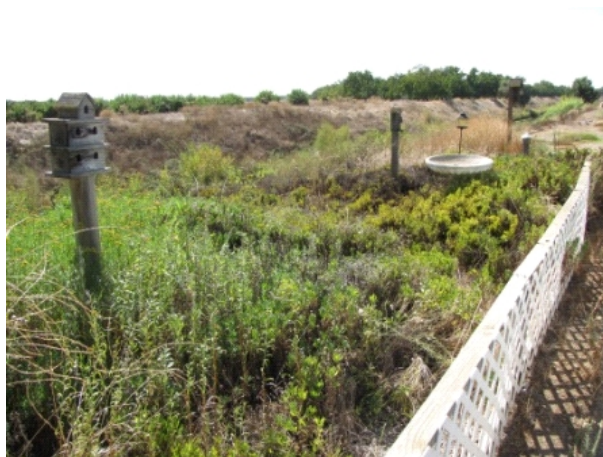
Levee Mile Report Line	73
Start Levee Mile	5.42
End Levee Mile	5.42
Location	Water Side
Category	Earthen Levee
Item	Encroachments

View of landscaping planted along the waterward side of the access road impacting visibility and the ability to floodfight looking downstream.

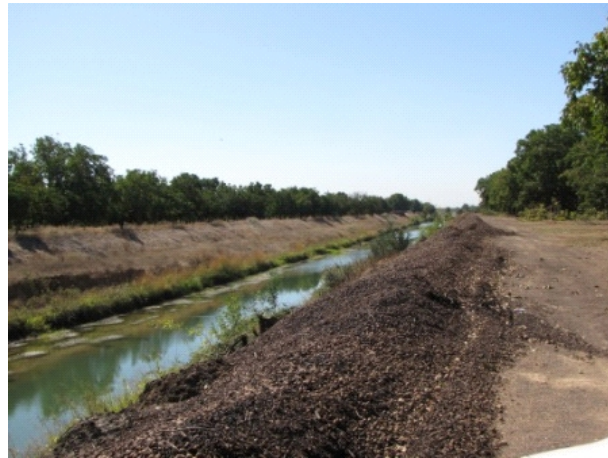
View of discarded nut shells placed along the waterward slope to be burned looking downstream.

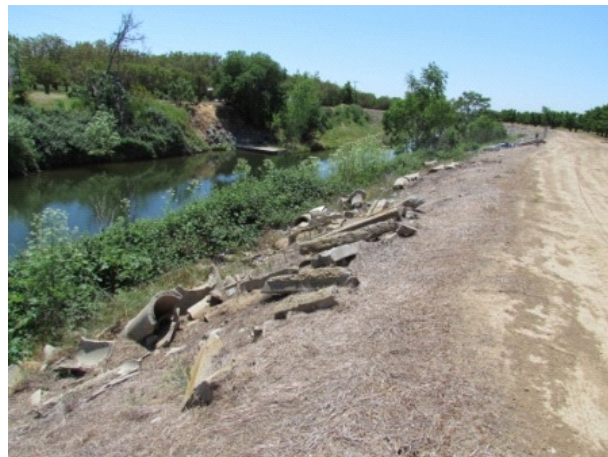
Levee Mile Report Line	76
Start Levee Mile	5.76
End Levee Mile	5.86
Location	Water Side
Category	Earthen Levee
Item	Encroachments

Broken concrete pipes and other debris was found on the waterside of the levee. The picture was taken from the crown looking downstream.

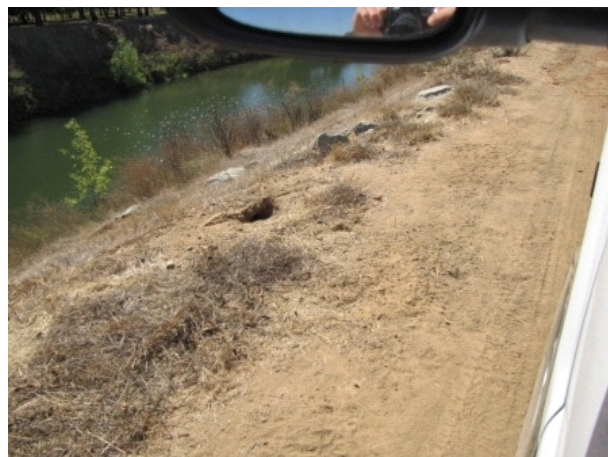
Levee Mile Report Line	77
Start Levee Mile	5.92
End Levee Mile	5.92
Location	Water Side
Category	Earthen Levee
Item	Animal Control

View of rodent activity in the waterward slope looking downstream.

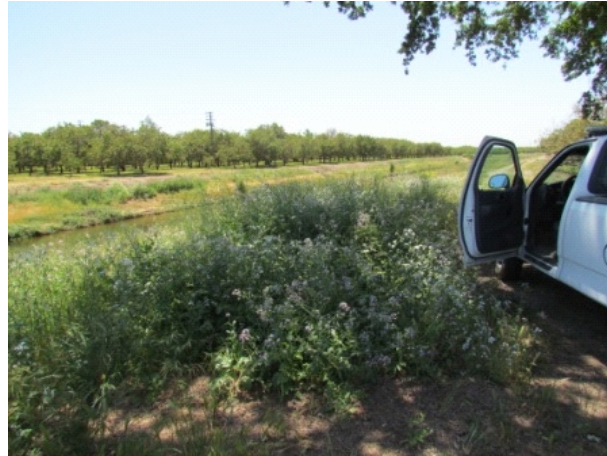
Wild growth on the waterside of the levee obstructing the view of the levee. The picture was taken from the crown looking downstream.

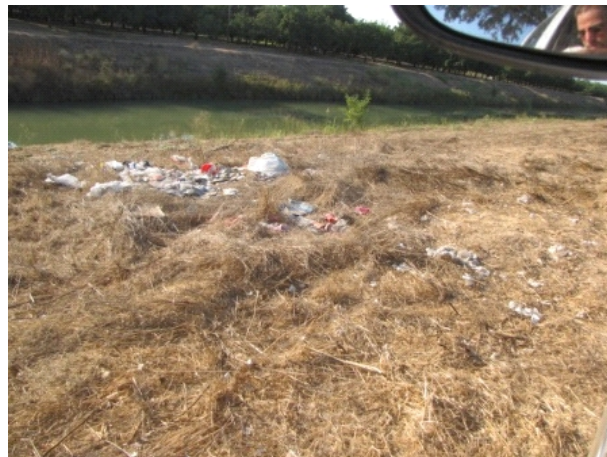
Levee Mile Report Line	82
Start Levee Mile	6.55
End Levee Mile	6.55
Location	Water Side
Category	Earthen Levee
Item	Encroachments

View of garbage on the waterward slope and berm looking downstream.

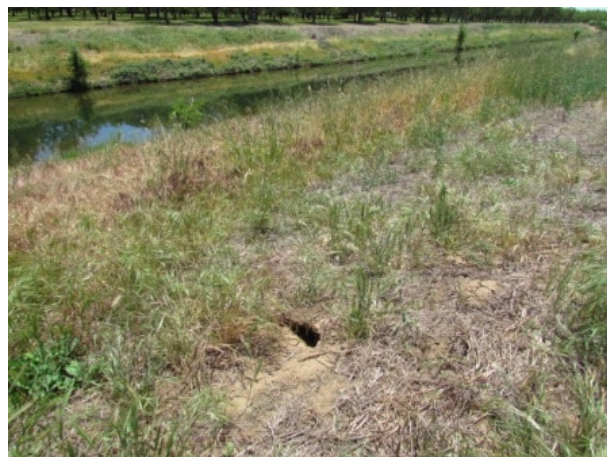
Levee Mile Report Line	83
Start Levee Mile	6.58
End Levee Mile	6.58
Location	Water Side
Category	Earthen Levee
Item	Animal Control

A rodent hole was found on the waterside of the levee. The picture was taken from the crown looking downstream.

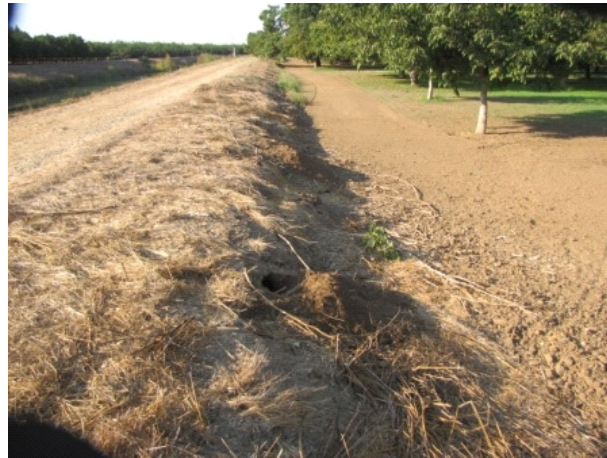
View of rodent activity in the landward slope looking downstream.

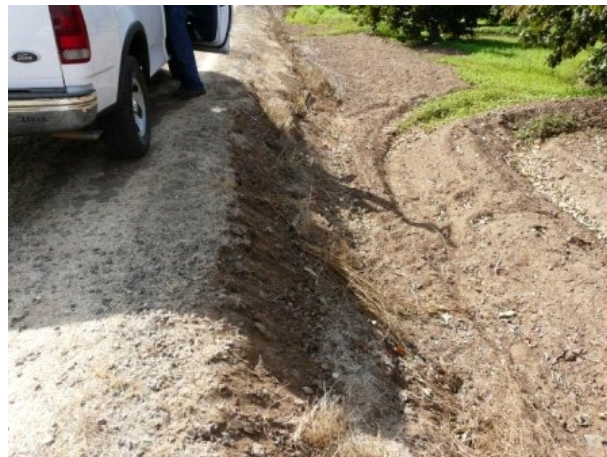
Levee Mile Report Line	89
Start Levee Mile	6.75
End Levee Mile	6.88
Location	Land Side
Category	Earthen Levee
Item	Erosion / Bank Caving

Farming equipment grading into the landside toe of the levee located at LM 6.90. Backfill and compact to design shape and attempt to prevent future damage.

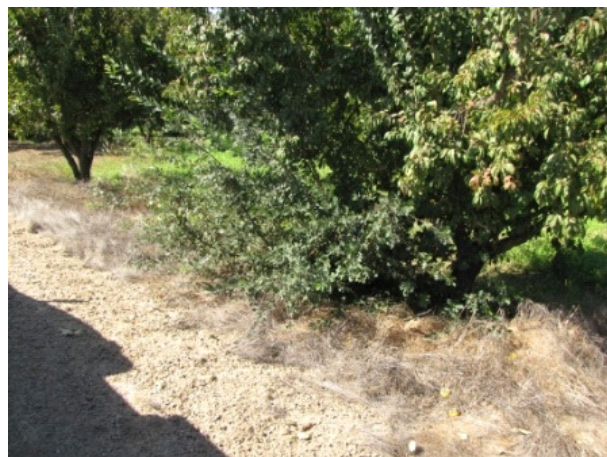
pkazi_s_20110328_263.jpg

View of trees obstructing visibility and the ability to floodfight along the landward slope.

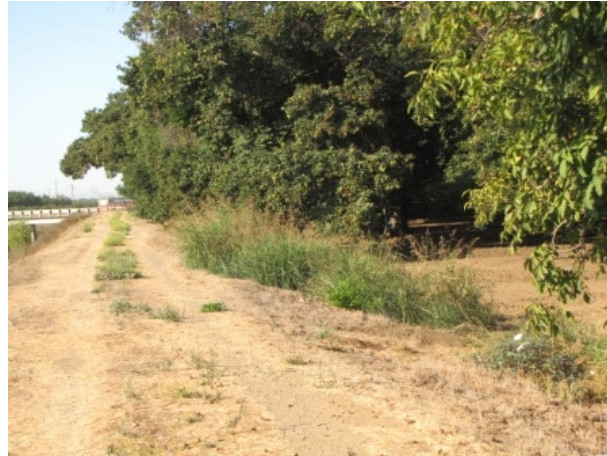
pkazi_s_20110328_231.jpg

View of vegetation on the landward slope blocking visibility looking downstream.

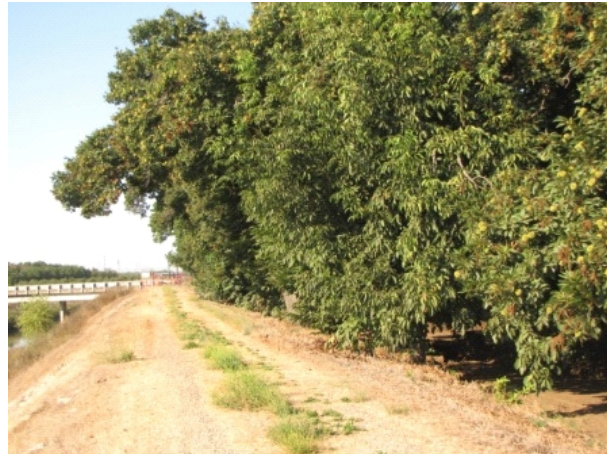
pkazi_s_20110328_232.jpg

Levee Mile Report Line	93
Start Levee Mile	6.98
End Levee Mile	7.06
Location	Land Side
Category	Earthen Levee
Item	Trim / Thin Trees

View of tree branches on the landward slope blocking visibility looking downstream.

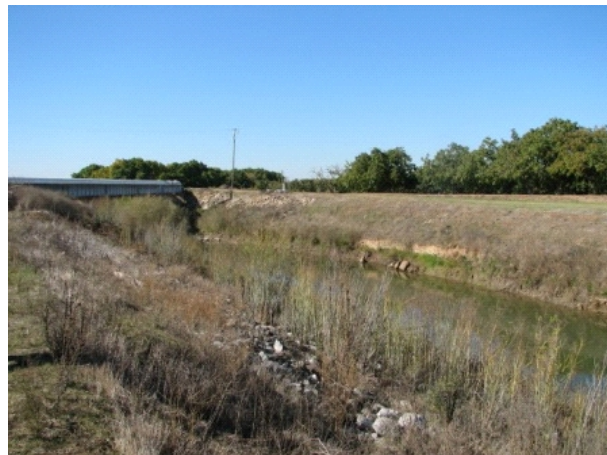
pkazi_s_20110328_185.jpg

Levee Mile Report Line	96
Start Levee Mile	7.23
End Levee Mile	7.23
Location	Water Side
Category	Supplemental
Item	DWR Erosion Survey

Looking downstream at the site.

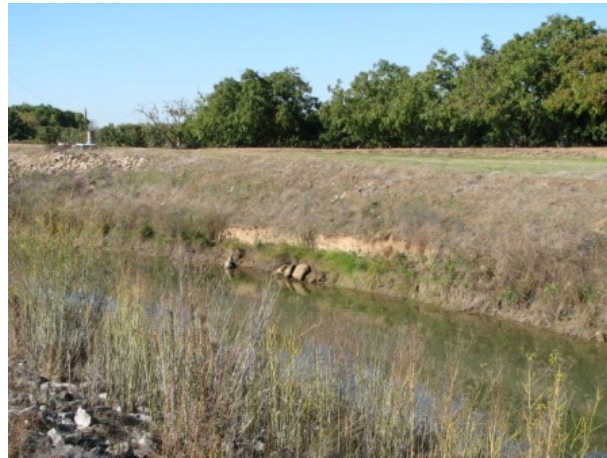
pkazi_s_20110328_186.jpg

Looking downstream at the site.

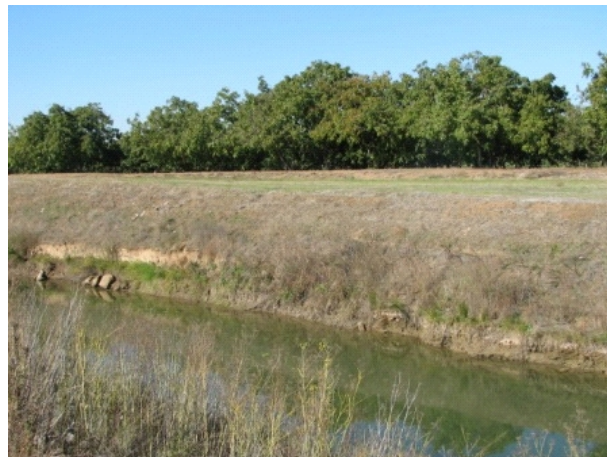
pkazi_s_20110328_187.jpg

Levee Mile Report Line	96
Start Levee Mile	7.23
End Levee Mile	7.23
Location	Water Side
Category	Supplemental
Item	DWR Erosion Survey

Looking downstream at the bank scarp. Minor erosion is not affecting the levee due to a wide berm.

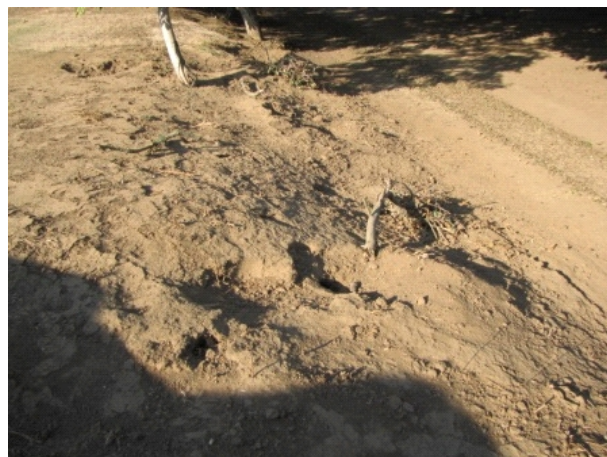
pkazi_s_20110328_234.jpg

Levee Mile Report Line	97
Start Levee Mile	7.24
End Levee Mile	7.29
Location	Land Side
Category	Earthen Levee
Item	Animal Control

View of rodent activity in the landward slope looking downstream.

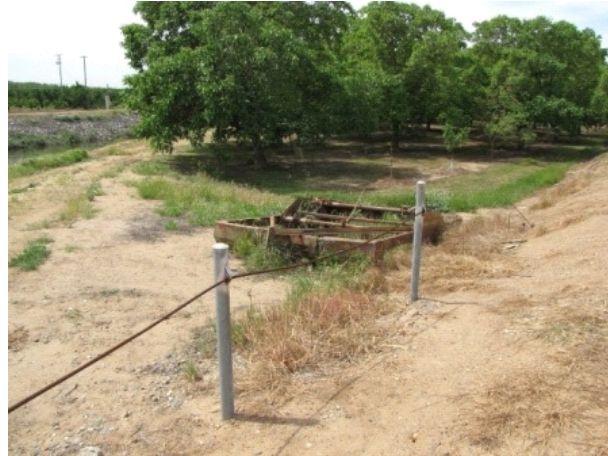
Levee Mile Report Line	99
Start Levee Mile	7.40
End Levee Mile	7.40
Location	Land Side
Category	Earthen Levee
Item	Encroachments
Move farmer's equipment 10' away from access road/levee.	
pkazi_s_20110328_255.jpg

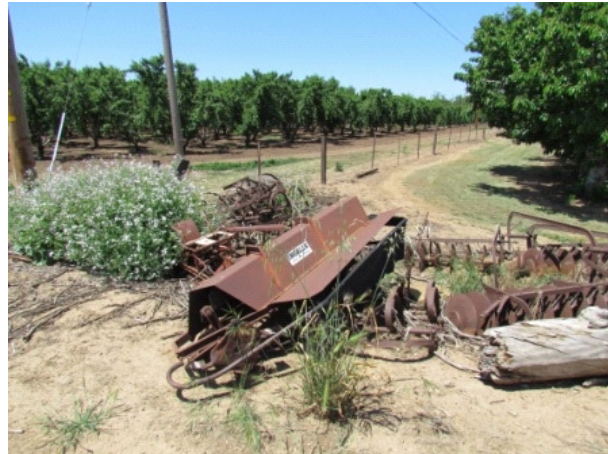
Levee Mile Report Line	103
Start Levee Mile	7.98
End Levee Mile	7.98
Location	Land Side
Category	Earthen Levee
Item	Encroachments
Equipments were left out by the farmers on the landside of the levee. The picture was taken from crown looking toward the landside of the levee.	
pkazi_s_20110519_570.jpg

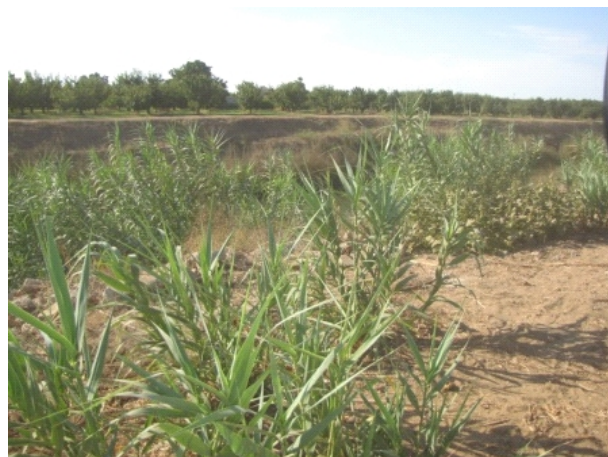
Levee Mile Report Line	104
Start Levee Mile	8.06
End Levee Mile	8.06
Location	Water Side
Category	Earthen Levee
Item	Vegetation
View of arrundo on the waterward shoulder and slope blocking visibility looking downstream.	
pkazi_s_20110328_235.jpg

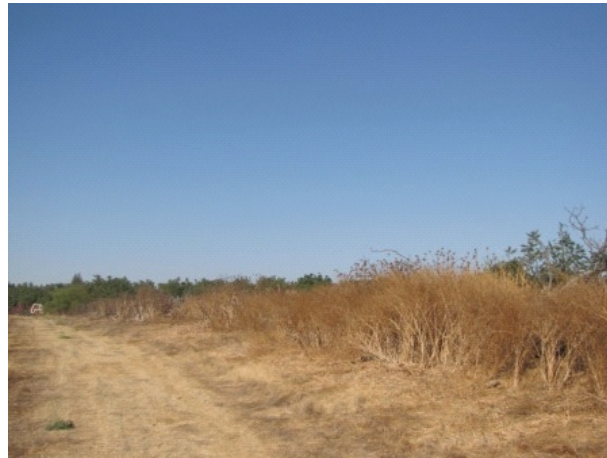
pkazi_s_20110328_236.jpg

View of vegetation and prunings on what is believed to be the crown of the levee looking downstream.

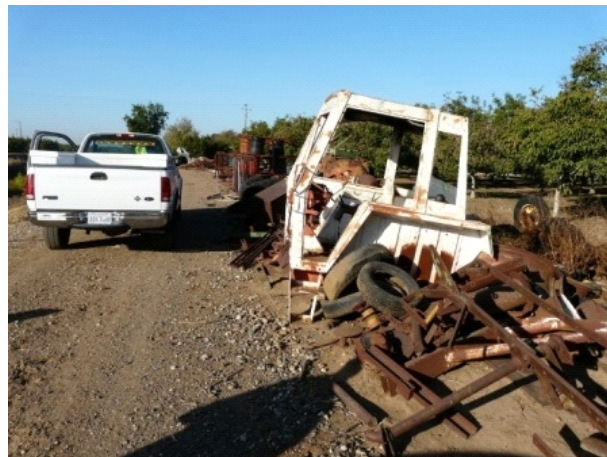
pkazi_s_20110328_200.JPG

Levee Mile Report Line	110
Start Levee Mile	8.68
End Levee Mile	8.70
Location	Land Side
Category	Earthen Levee
Item	Encroachments

Remove equipment from landside slope of levee at from LM 8.68 to LM 8.70.

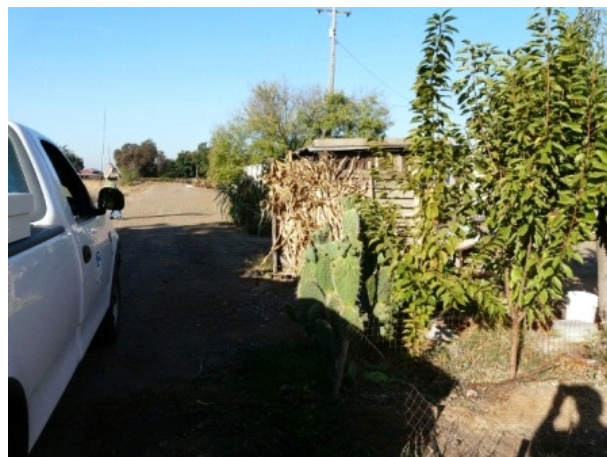
pkazi_s_20110328_228.JPG

Levee Mile Report Line	111
Start Levee Mile	8.72
End Levee Mile	8.72
Location	Land Side
Category	Earthen Levee
Item	Encroachments

Building, fence and landscaping immediately adjacent to the access road at LM 8.72.

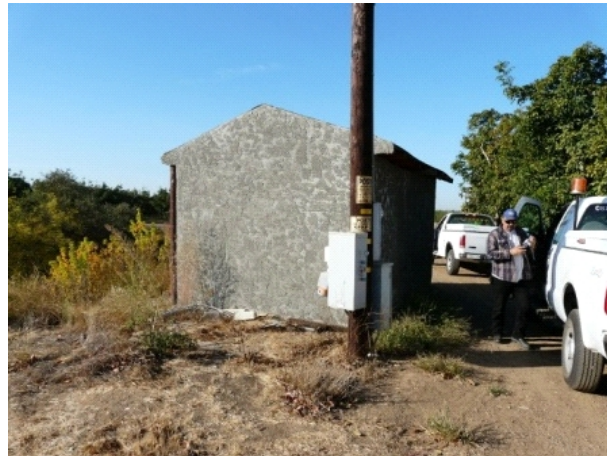
Levee Mile Report Line	114
Start Levee Mile	9.63
End Levee Mile	9.63
Location	Water Side
Category	Earthen Levee
Item	Encroachments
Building located at LM 9.63 on waterside of access road. This building appears to be recently constructed and does not currently contain anything.	
pkazi_s_20110328_202.JPG

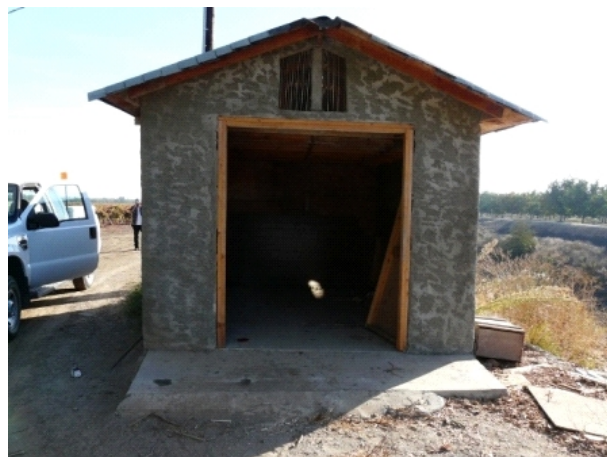
Levee Mile Report Line	114
Start Levee Mile	9.63
End Levee Mile	9.63
Location	Water Side
Category	Earthen Levee
Item	Encroachments
Additional view of building at LM 9.63.	
pkazi_s_20110328_203.JPG

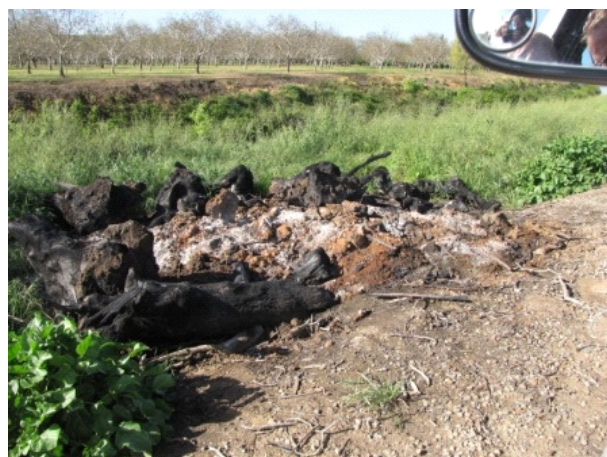
Levee Mile Report Line	118
Start Levee Mile	10.62
End Levee Mile	10.62
Location	Water Side
Category	Earthen Levee
Item	Encroachments
View of the prunings pile on the waterward slope looking downstream.	
pkazi_s_20110328_223.jpg

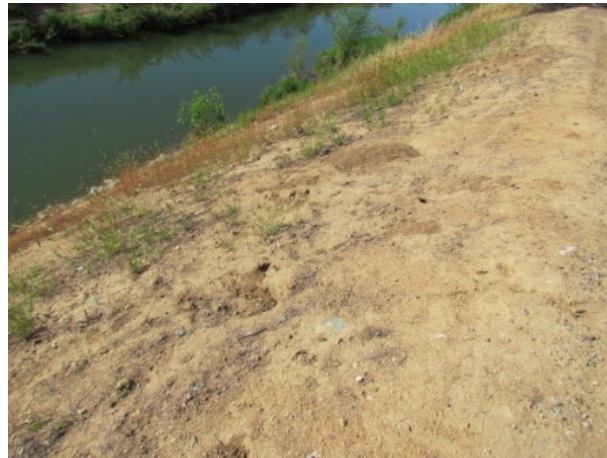
pkazi_s_20110519_571.jpg

Rodent holes was found on the waterside of the levee. The picture was taken from the crown looking downstream.

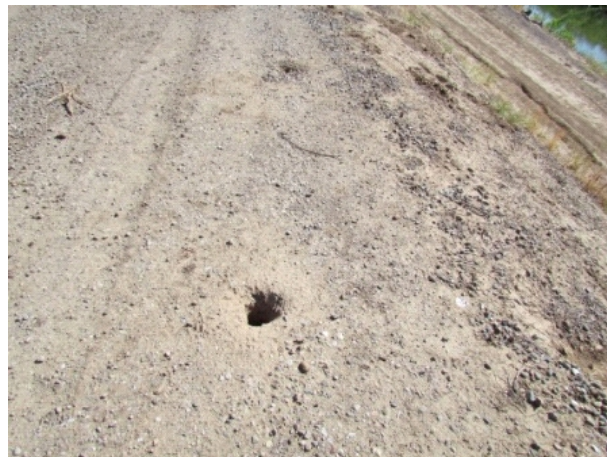
pkazi_s_20110519_572.jpg

Levee Mile Report Line	124
Start Levee Mile	11.11
End Levee Mile	11.11
Location	Crown
Category	Earthen Levee
Item	Animal Control

A rodent hole was found on the crown. The picture was taken from the crown looking upstream.

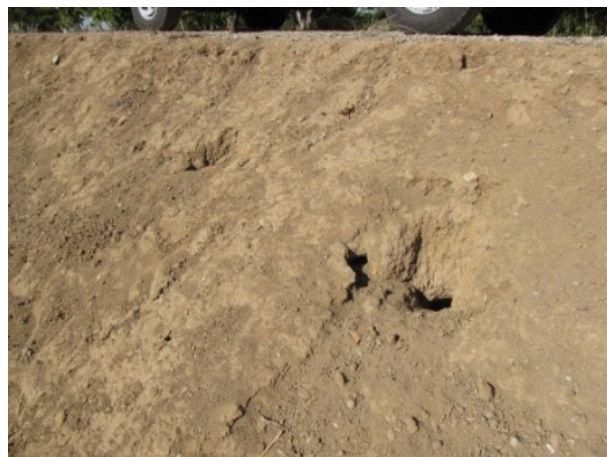
pkazi_s_20110328_265.jpg

Levee Mile Report Line	125
Start Levee Mile	11.12
End Levee Mile	11.15
Location	Water Side
Category	Earthen Levee
Item	Animal Control

View of rodent holes in the waterward slope.

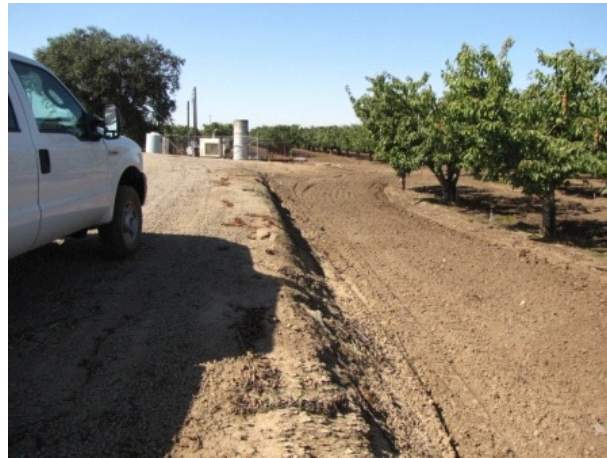
pkazi_s_20110328_237.jpg

View of the damage caused to the levee by a farmer's tilling activity looking downstream.

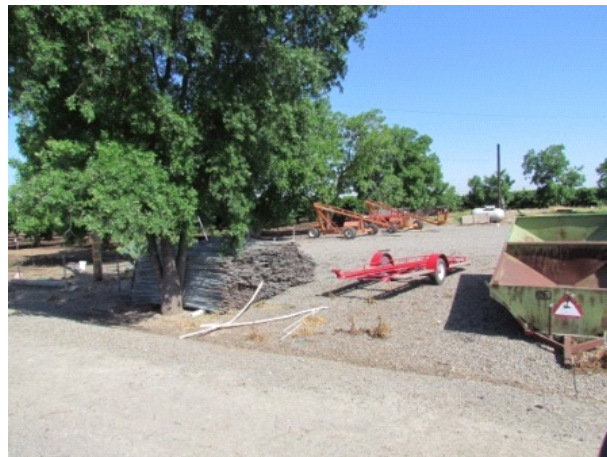
pkazi_s_20110519_573.jpg

Levee Mile Report Line	127
Start Levee Mile	11.58
End Levee Mile	11.58
Location	Land Side
Category	Earthen Levee
Item	Encroachments

Equipments on the landside of the levee. The picture was taken from the crown looking downstream.

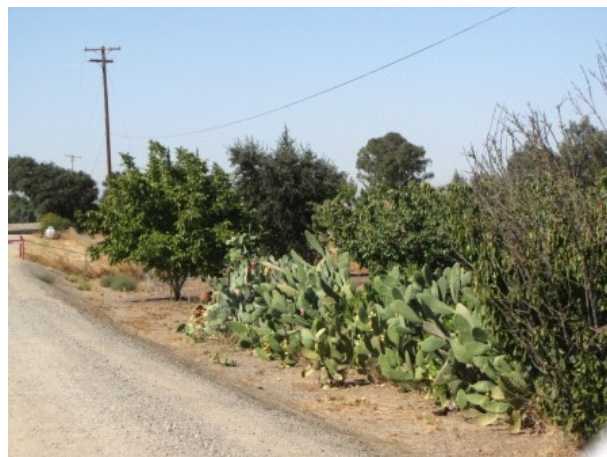
pkazi_s_20110328_238.jpg

Levee Mile Report Line	128
Start Levee Mile	11.61
End Levee Mile	11.61
Location	Land Side
Category	Earthen Levee
Item	Encroachments

View of cactus within 10 feet of the landward toe blocking visibility and access.

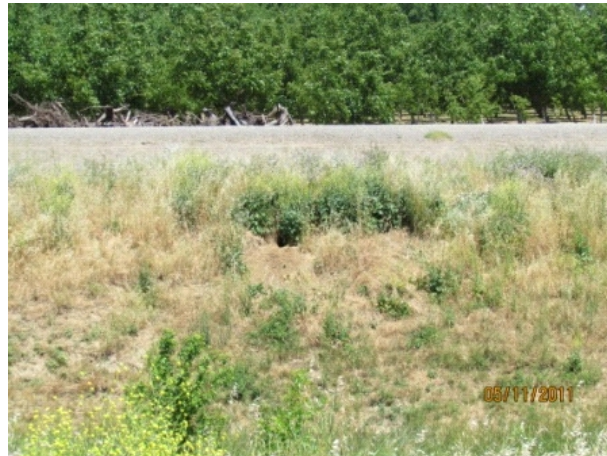
pkazi_s_20110523_592.jpg

A rodent hole was discovered on the waterside slope of the levee. The picture was taken from the opposite side of the channel.

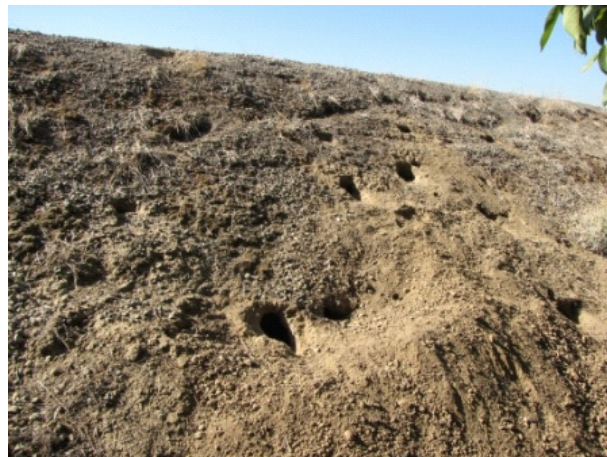
pkazi_s_20110328_266.jpg

Levee Mile Report Line	135
Start Levee Mile	12.78
End Levee Mile	12.78
Location	Land Side
Category	Earthen Levee
Item	Animal Control

View of rodent holes in the landward slope of the levee.

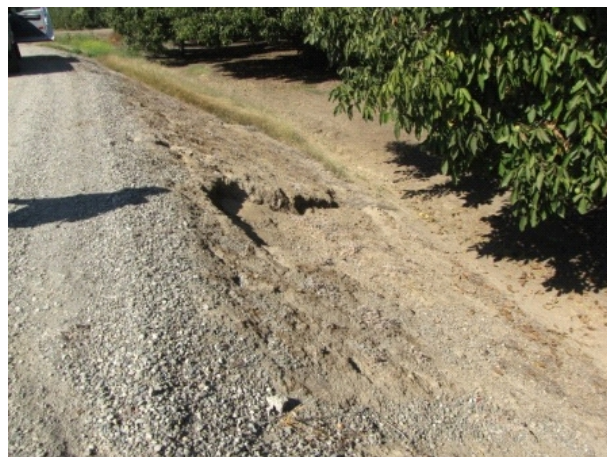
pkazi_s_20110328_239.jpg

Levee Mile Report Line	136
Start Levee Mile	12.80
End Levee Mile	12.80
Location	Water Side
Category	Earthen Levee
Item	Erosion / Bank Caving

View of erosion occurring on the landward slope looking downstream.

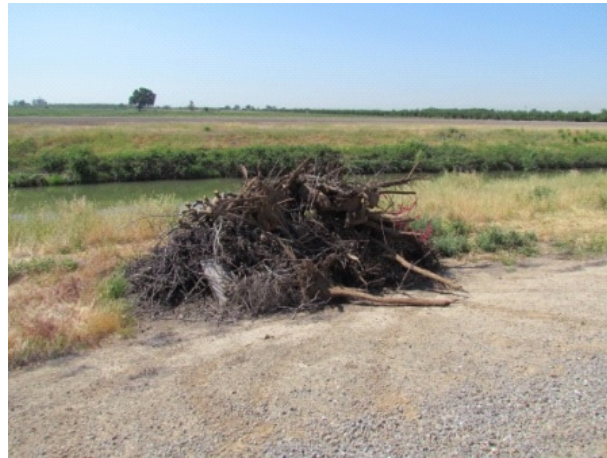
pkazi_s_20110519_574.jpg

Pruning on the waterside of the levee looking downstream.

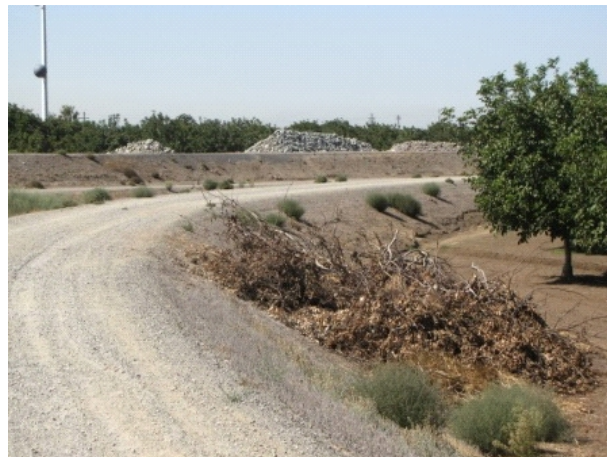
pkazi_s_20110328_241.jpg

Levee Mile Report Line	145
Start Levee Mile	13.58
End Levee Mile	13.58
Location	Land Side
Category	Earthen Levee
Item	Encroachments

View of a prunings pile on the landward slope looking downstream. The resident stated it would be moved in a few weeks.

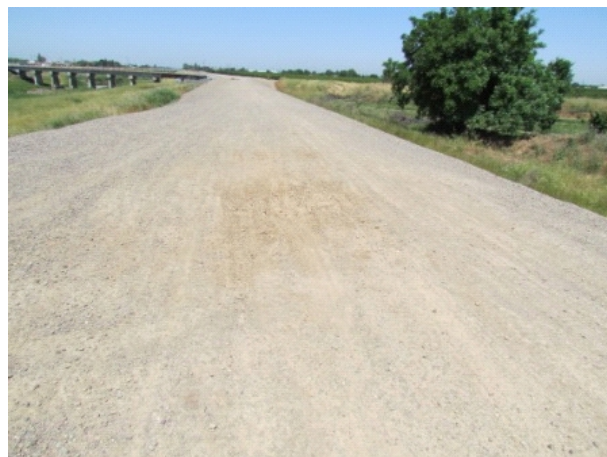
pkazi_s_20110519_576.jpg

Levee Mile Report Line	149
Start Levee Mile	14.85
End Levee Mile	14.85
Location	Crown
Category	Earthen Levee
Item	Crown Surface / Depressions / Rutting

Crown depression was discovered possible caused by vehicular traffic. The picture was taken from the crown looking downstream.

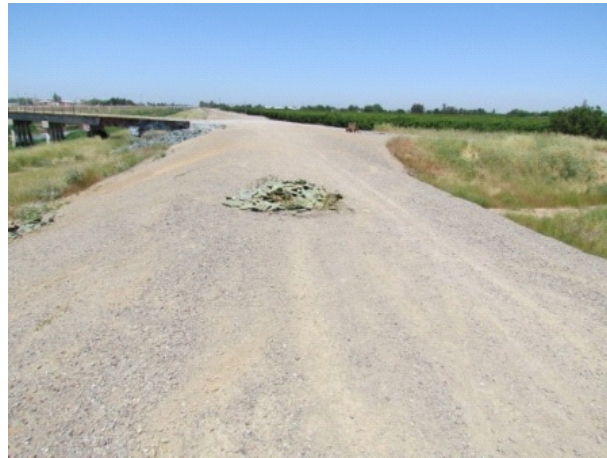
pkazi_s_20110519_577.jpg

Cactus was found on the middle of the crown. The picture was taken from the crown looking downstream.

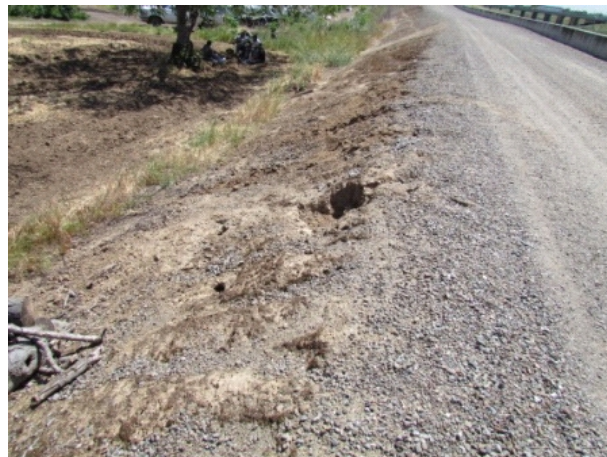
pkazi_s_20110519_578.jpg

Levee Mile Report Line	153
Start Levee Mile	15.70
End Levee Mile	15.74
Location	Land Side
Category	Earthen Levee
Item	Animal Control

Multiple rodent holes was found on the landside of the levee. The picture was taken from the crown looking upstream.

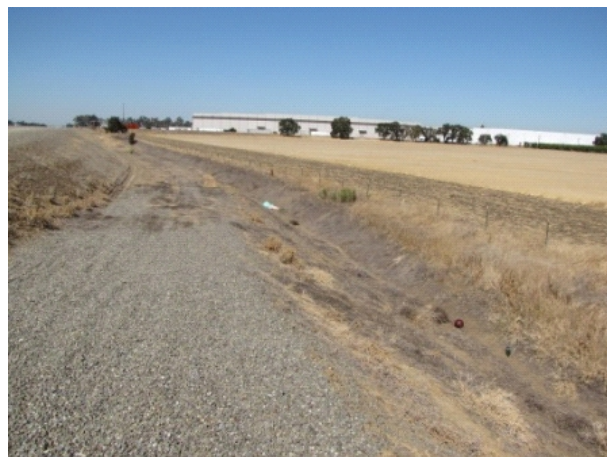
pkazi_s_20110328_267.jpg

Levee Mile Report Line	156
Start Levee Mile	16.09
End Levee Mile	16.60
Location	Land Side
Category	Earthen Levee
Item	Encroachments

View of a ditch adjacent to the landward toe looking downstream.

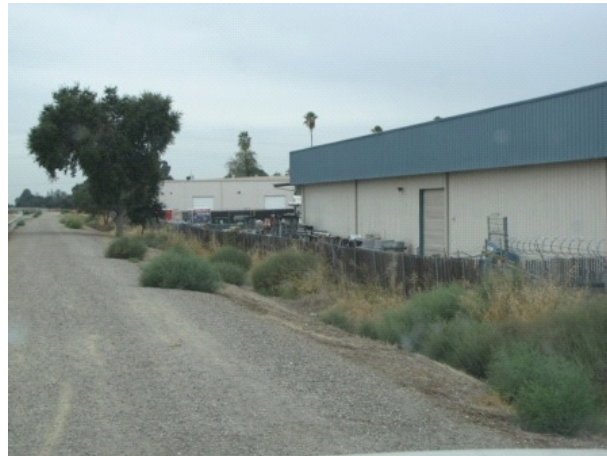
pkazi_s_20110328_245.jpg

View of vegetation blocking visibility along the landward slope looking downstream.

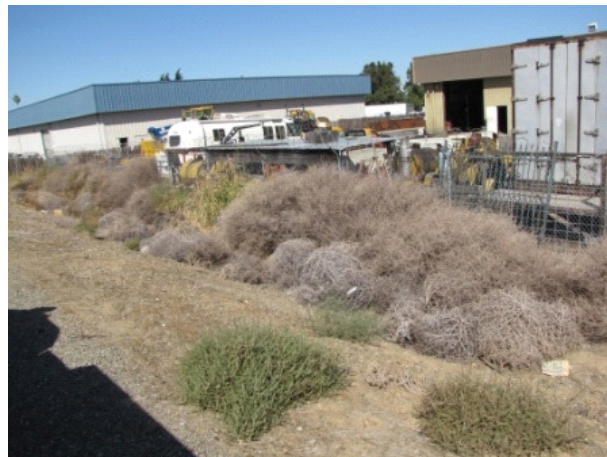
pkazi_s_20110328_268.jpg

Levee Mile Report Line	163
Start Levee Mile	17.23
End Levee Mile	17.69
Location	Land Side
Category	Earthen Levee
Item	Encroachments

View of vegetation blocking visibility and access along the landward toe looking downstream.

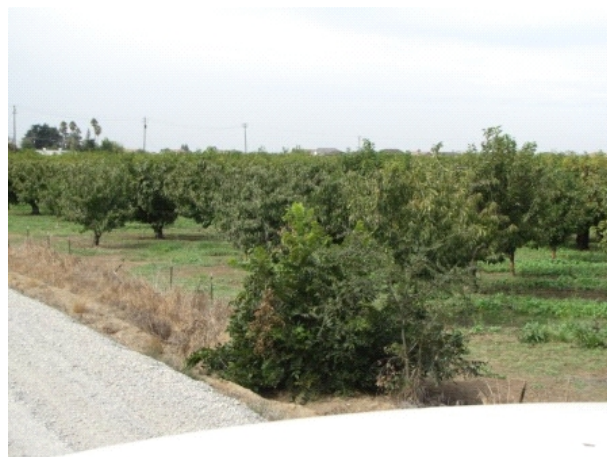
pkazi_s_20110328_247.jpg

Levee Mile Report Line	168
Start Levee Mile	18.10
End Levee Mile	18.10
Location	Land Side
Category	Earthen Levee
Item	Trim / Thin Trees

View of a small clump of trees on the landward slope blocking visibility and access looking downstream.

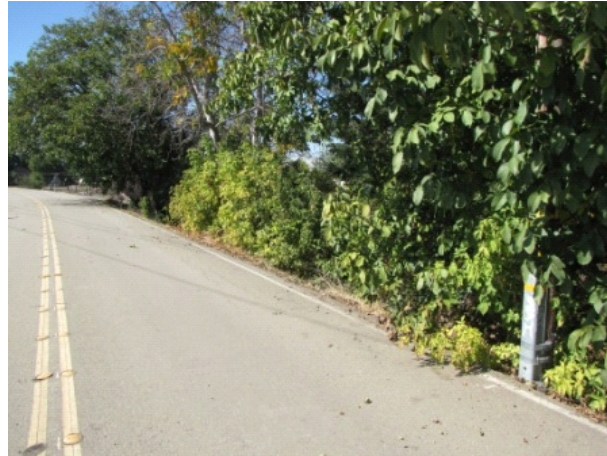
pkazi_s_20110328_270.jpg

View of landowner planted and maintained vegetation along the landward slope looking downstream.

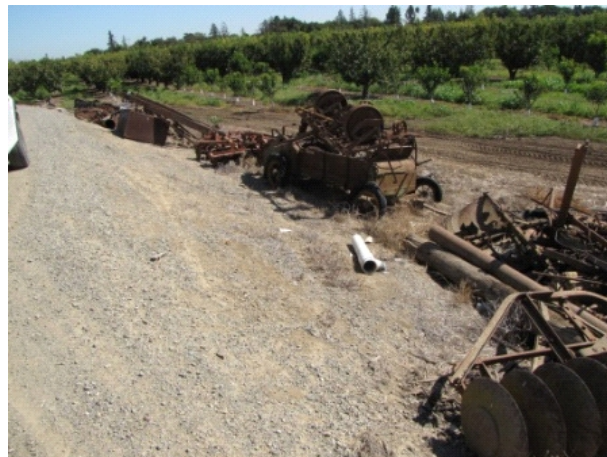
pkazi_s_20110328_269.jpg

Levee Mile Report Line	173
Start Levee Mile	18.62
End Levee Mile	18.62
Location	Land Side
Category	Earthen Levee
Item	Encroachments

View of equipment on the landward slope and toe looking downstream.

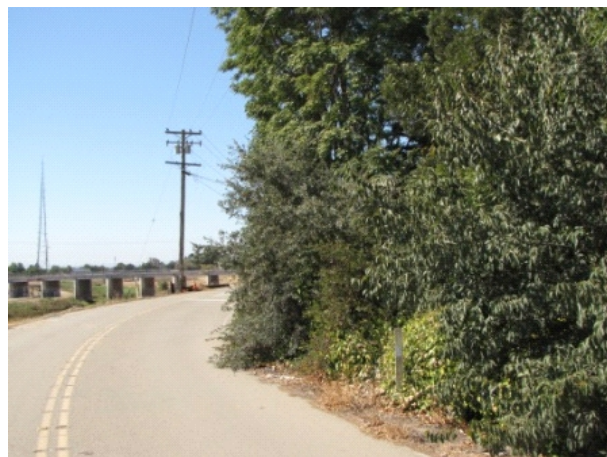
pkazi_s_20110328_271.jpg

Levee Mile Report Line	175
Start Levee Mile	19.80
End Levee Mile	19.86
Location	Land Side
Category	Earthen Levee
Item	Encroachments

View of landowner planted and maintained vegetation along the landward slope looking downstream.

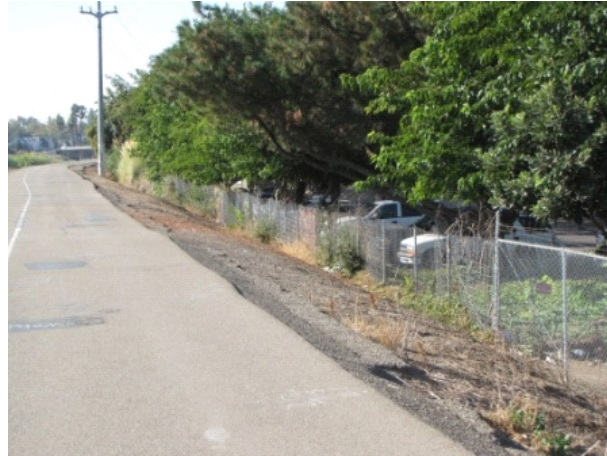
pkazi_s_20110328_272.jpg

View of fence along the landward toe looking downstream.

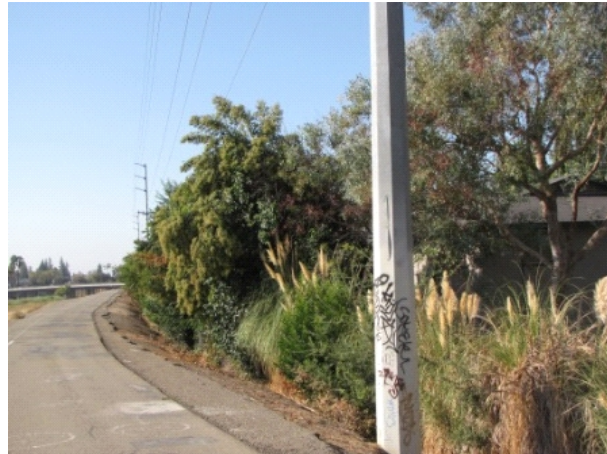
pkazi_s_20110328_209.jpg

Levee Mile Report Line	188
Start Levee Mile	21.52
End Levee Mile	21.73
Location	Land Side
Category	Earthen Levee
Item	Encroachments

View of landscaping along the landward slope and toe looking downstream.
